# Trans-cuff leakage in bio-Bentall operation

October 6, 2021

We have reported a case of trans-cuff leakage that occurred in a composite graft of bio-Bentall operation. The leakage resolved several months after surgery, similar to the trans-cuff leakage seen in simple aortic valve replacement. We have proposed hypotheses on the mechanism of trans-cuff leakage during a bio-Bentall operation and suggested ways to prevent it from occurring.

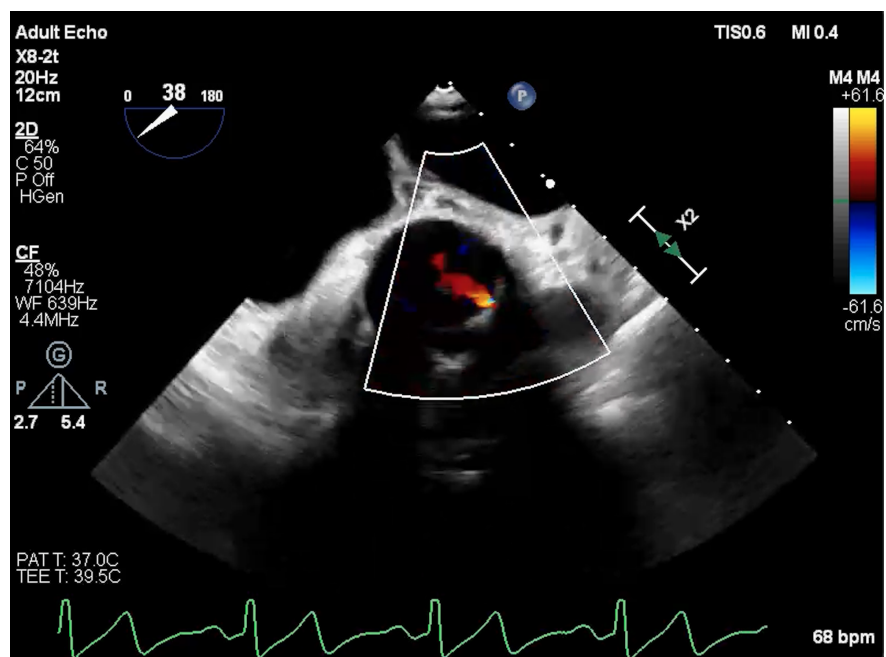
### Figure 1

Intra-operative transesophageal echocardiography showing mild leakage from the left-right stent post and the regurgitation jet blowing vertically from the sewing-cuff.

A 68-year-old man with a dilated sinus of Valsalva and moderate aortic regurgitation underwent bio-Bentall operation. The sinus of Valsalva was 49 mm in diameter and the sino-tubular junction was 40 mm in diameter. The composite graft was prepared by hand sewing a 27-mm INSPIRIS RESILIA valve into a 30-mm Gelweave Valsalva (Vascutek Ltd., Inchinnan, UK) with a running 2-0 braided polyester suture. More specifically, the bioprosthesis was placed on top of the collar under the skirt of the graft. The composite graft was implanted supra-annularly with 2-0 pledgetted braided polyester non-everting mattress sutures. The threads were not applied to the sewing-cuff of the bioprosthesis, but it was applied to the graft collar. Finally, the edge of the graft collar and remnant of the Valsalva wall were sutured with a running 4-0 polypropylene suture to reinforce and the proximal anastomosis was completed. Reimplantation of the coronary ostia and distal anastomosis were performed in the standard fashion. Intra-operative transesophageal echocardiography (TEE) showed mild leakage blowing vertically from the sewing-cuff just below the left-right stent post (Figure 1 and Video 1). We judged the leakage to be trans-cuff leakage, which occasionally occurs in this particular bioprosthesis, and proceeded to complete the operation. Trivial trans-cuff leakage was noted on transthoracic echocardiography (TTE) performed 11 days postoperatively, and the patient was discharged. Trans-cuff leakage disappeared completely on TTE performed 6 months postoperatively.

As in the present case, it is unclear why trans-cuff leakage occurs when the bioprosthesis is fixed to an artificial graft. In our case, we sewed suture threads from the outside of the graft at the middle of the graft to fix the bioprosthesis. The sewing-cuff must be sewn out of sight because the bioprosthesis was sewn in the middle and not at the edge of the graft. As a result, the depth of the sutures was uneven. In addition to the anatomical cause of trans-cuff leakage, Hiraoka et al. pointed out that applying stitches to the edges of the sewing-cuff increases the risk of leakage [3]. Trans-cuff leakage may have occurred because the sewing-cuff was sewn shallowly near the stent post, and the weak point of the sewing-cuff was stretched.
