Bicuspid aortic valve caused subaortic stenosis with bulging of valve calcification through subaortic area in a young patient

February 16, 2023

Running title: Bicuspid Aorta and Subaortic Stenosis

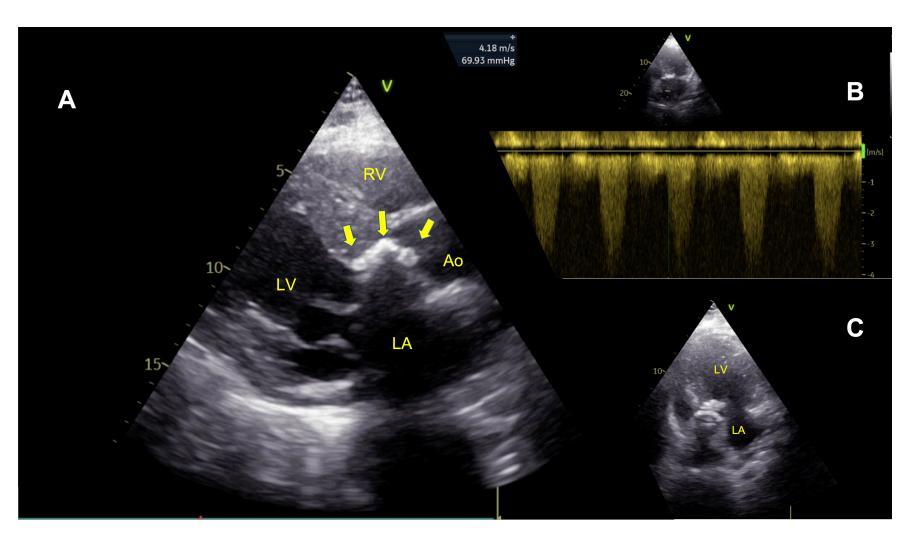
Figure 1. (A)Parasternal long axis view of transthoracic echocardiography (TTE) showing calcification of aortic valve extending to the interventricular septum (arrows). (B) Continuous wave doppler of TTE showing severe gradient in left ventricular outflow tract (C) Apical view of TTE showing calcification. RA, right atrium; LA, left atrium; RV, right ventricle; LV, left ventricle; Ao, aorta. Figure 2. (A, B) Transesophageal echocardiography (TEE) revealing calcification (arrows) attached to the interventricular septum and causing subaortic stenosis (C,D) Computed tomography showing eccentric calcification of aortic valve. RA, right atrium; LA, left atrium; LV, left ventricle; Ao, aorta.

A 28-year-old man admitted our outpatient cardiology clinic with exertional dyspnea. He has been diagnosed with bicuspid aortic valve for five years ago, however, he did not go routine follow-up. Cardiac examination revealed regular pulse (90 beats/min) with normal blood pressure and a 3/6 systolic crescendo-decrescendo murmur loudest at the right upper sternal border. Electrocardiography revealed normal sinus rhythm with left ventricular hypertrophy. Transthoracic echocardiography showed bicuspid aorta with aortic aneurysm and severe aortic regurgitation. Interestingly, severe calcification of the valve was extending to subvalvular area and causing severe left ventricular outflow tract obstruction (subaortic stenosis)(Figure 1, Video 1). Transesophageal echocardiography and computed tomography revealed that calcification was starting from coronary cusp and extending to the interventricular septum and caused severe septal hypertrophy (Figure 2, Video 2). The patient underwent aortic valve replacement with mechanical prosthesis and thoracic aorta replacement with a Dacron graft after heart team discussion. The patient was well after surgery and discharged without any problem (Figure 3, Video 3).

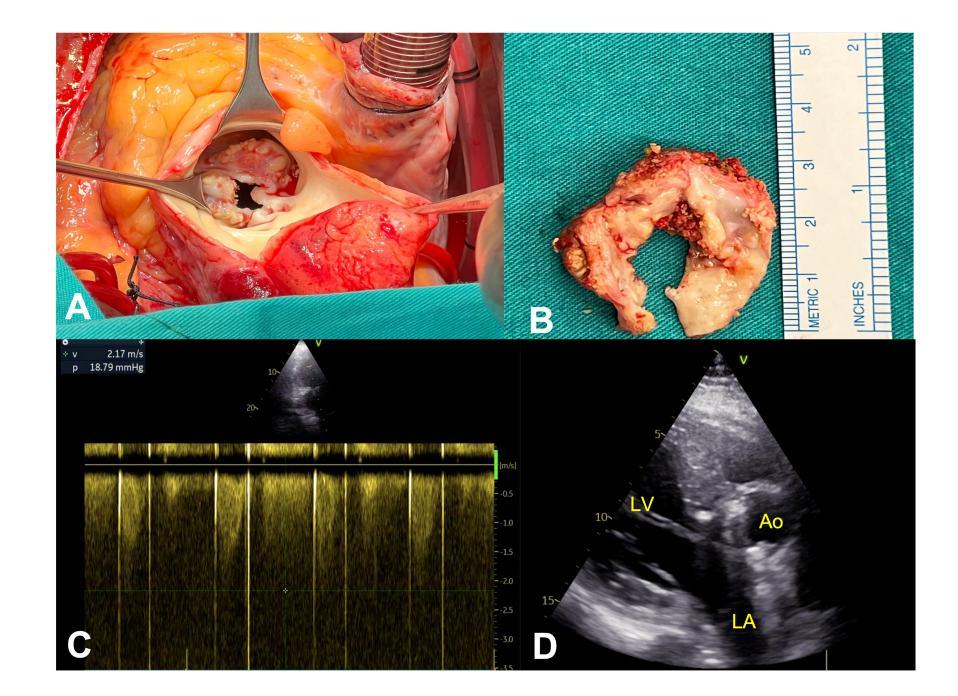
Figure 3. (A, B) Intraoperative view of aortic valve and partially resected calcification of interventricular septum. (C, D) Postoperative TTE showing mechanical aortic valve and diminished LVOT gradient. Video 2. TTE after operation.; LA, left atrium; LV, left ventricle; Ao, aorta.
