Aortic annulus elevation for aortic valve and root replacement

January 14, 2022

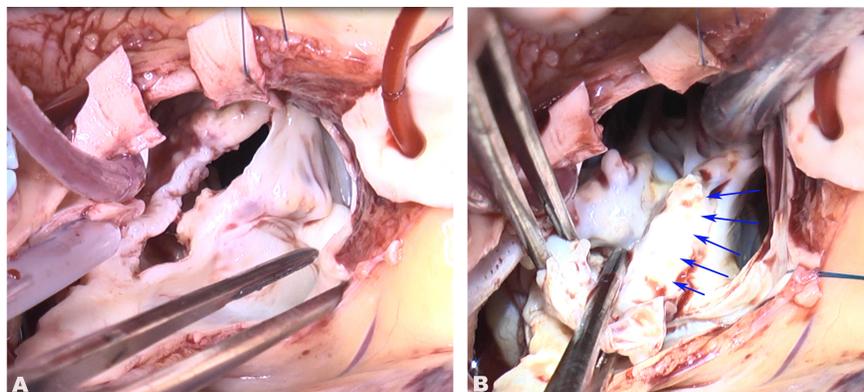
Figure 1. **A.** Severely calcified unicuspid aortic valve. **B.** *Blue arrows*, extension of calcifications onto the aortomitral curtain and anterior mitral valve leaflet.

The surgical technique is illustrated in the Video (Video 1, supplementary material). After excision of a severely calcified unicuspid valve and debridement of aortomitral curtain calcifications (Figure 1), we noticed the asymmetric aortic annulus with significant displacement of the left coronary aortic annulus into

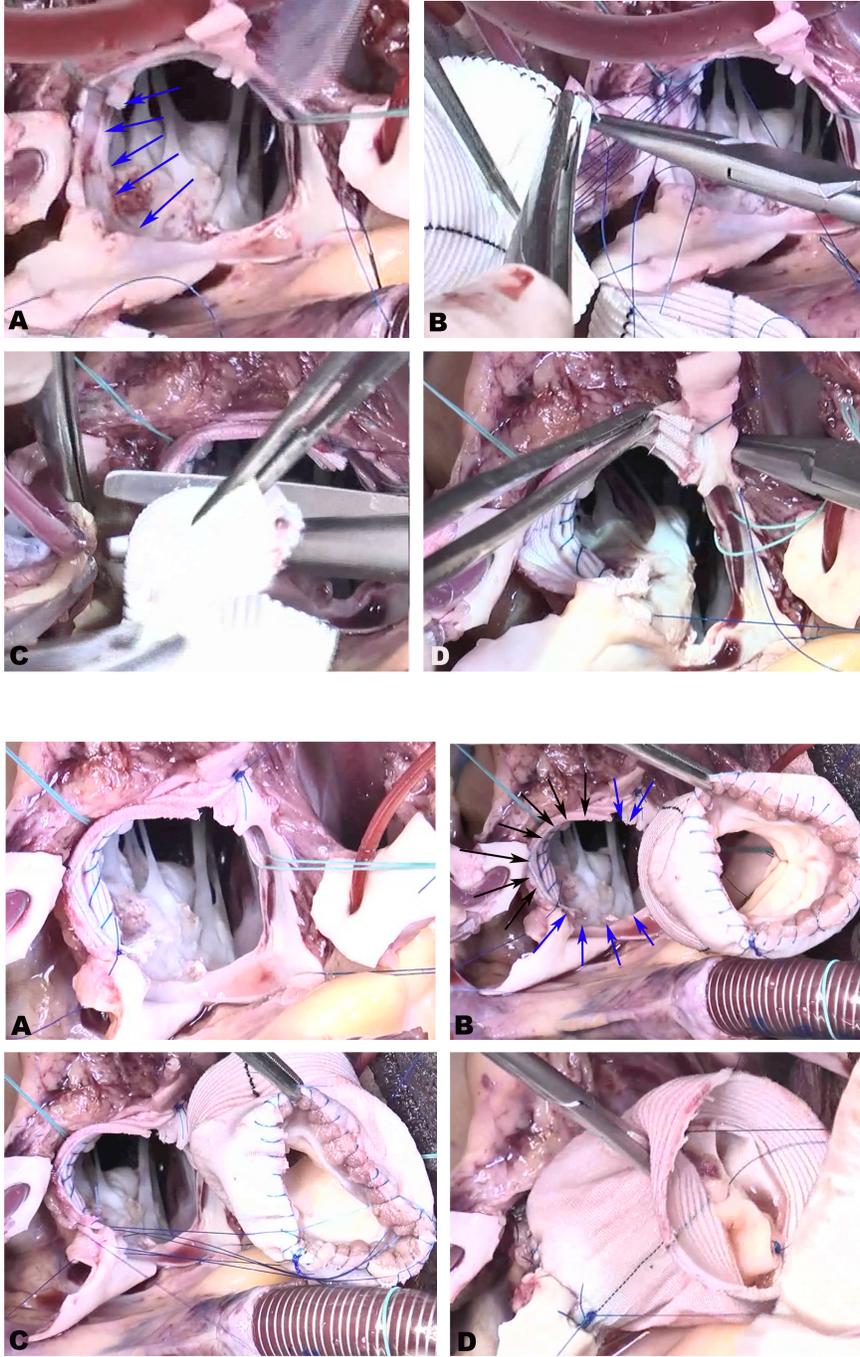
Figure 2. **A.** *Blue arrows*, depict displaced aortic annulus of the left coronary sinus into the LVOT, and below the level of the aortic annulus of the right- and non-coronary sinus. **B.** Sewing of a prosthetic graft to the displaced aortic annulus between left/right- to non/left- coronary commissure. **C.** Trimming of the graft to align the cut free edge of the graft with the aortic annulus of the right- and non-coronary sinus. **D.** Anchoring of the lateral 2 edges of the graft to the commissures.

Figure 3. **A.** Elevation of the left coronary sinus annulus with prosthetic graft material. **B.** *Black and blue arrows* , depict the new aortic annulus. **C.** Graft-reinforced pulmonary autograft is sewn to the aortic annulus. **D.** Seated pulmonary autograft onto the neo-aortic annulus.

the LVOT (Figure 2A). The leftover graft of a 28mm Cardioroot graft (Getinge, Sweden), which was used for pulmonary autograft reinforcement, was sewn to the aortic annulus of the left coronary sinus with a 4.0 Prolene suture (Figure 2B). The autograft reinforcement technique has been previously described in detail⁷. The graft was sewn to the aortic annulus effectively from the left/right- coronary commissure to the non/left- coronary commissure. During the surgery, we started the suture line in the middle of the sinus (Figure 2B) and completed the suture line on the displaced annulus and towards each commissure. Once the graft was seated and tied, it was cut and the free margin of the graft was trimmed to align with the height of the normal annulus of the non- and right coronary sinus (Figure 2C). An additional commissural stitch was placed at each commissure to secure the graft at the 2 lateral edges (Figure 2D). Upon completion of this step, a balanced aortic annulus was created with an even horizontal plane (Figure 3A), which would match the horizontal plane of the graft reinforced autograft (Video 1).

The pulmonary autograft was then sewn to the neo-aortic annulus with a running 4.0 Prolene suture (Figure 3B,C). This allowed for seating of the pulmonary autograft to an even and horizontally balanced aortic annulus, without any graft or neo-aortic valve distortion (Figure 3D).
